AFRL-VA-WP-TR-2003-3088

**INVESTIGATION OF THE EFFECT OF
CORROSION PITTING ON FATIGUE
LIFE OF ALUMINUM STRUCTURE**

Eric J. Tuegel

OCTOBER 2003

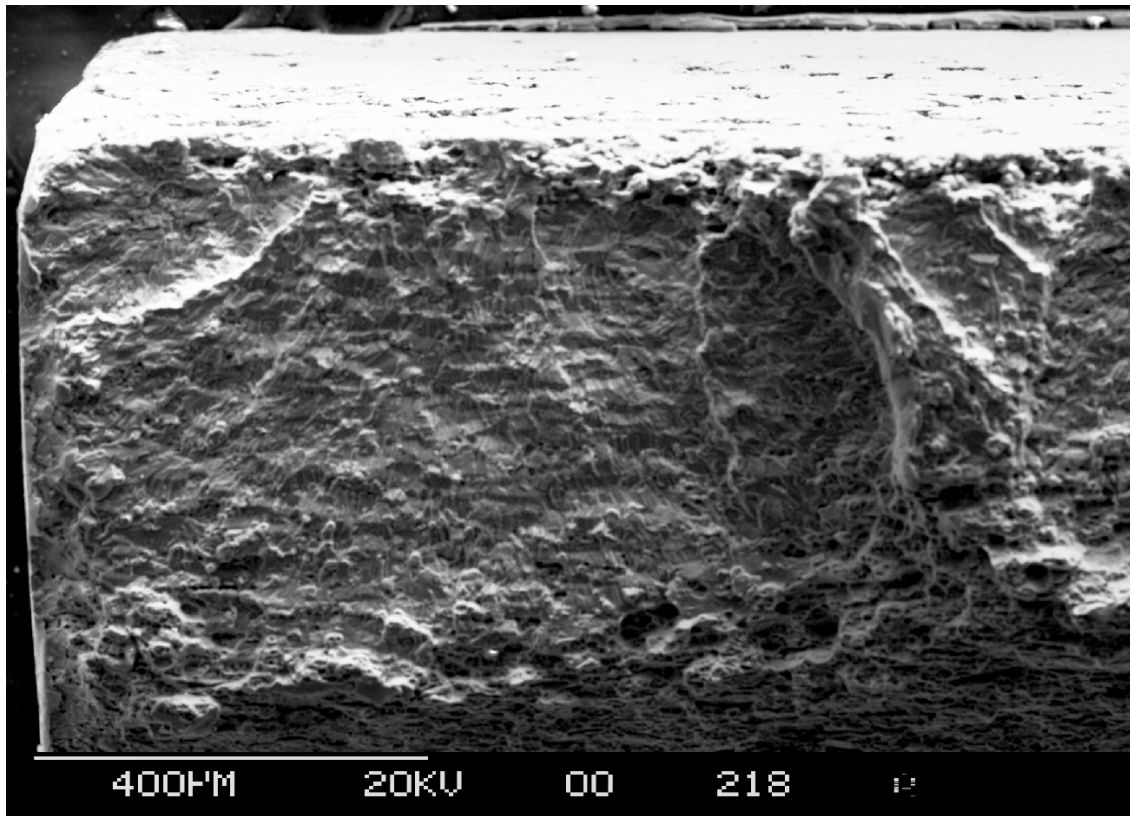
Figure B-59. Crack Origin #1 in Specimen 5914 (seen in Fig. B-58).

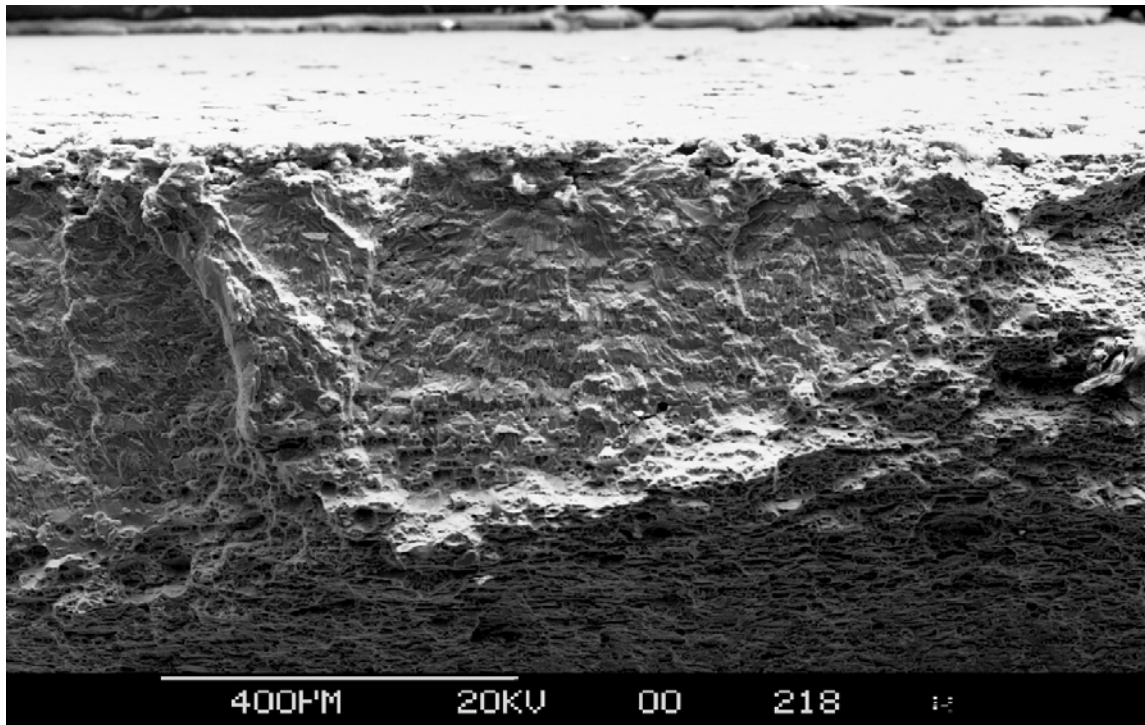
Figure B-60. Crack Origin #2 in Specimen 5914 (seen in Fig. B-58).

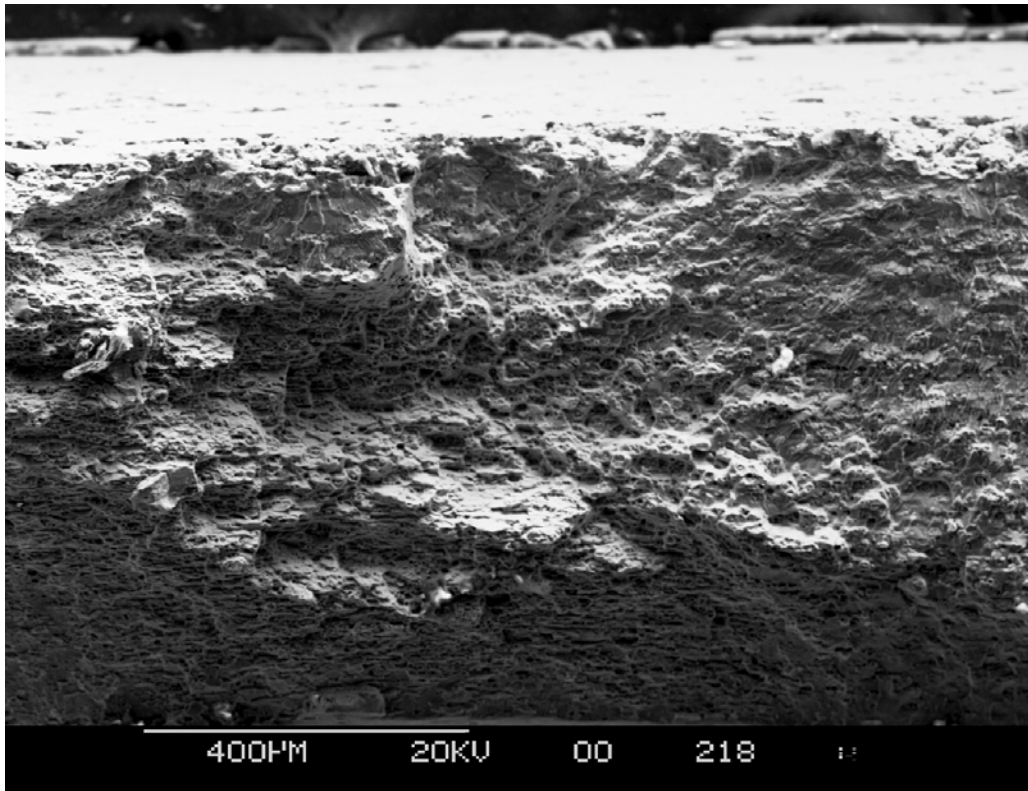
Figure B-61. Crack Origin #3 in Specimen 5914.

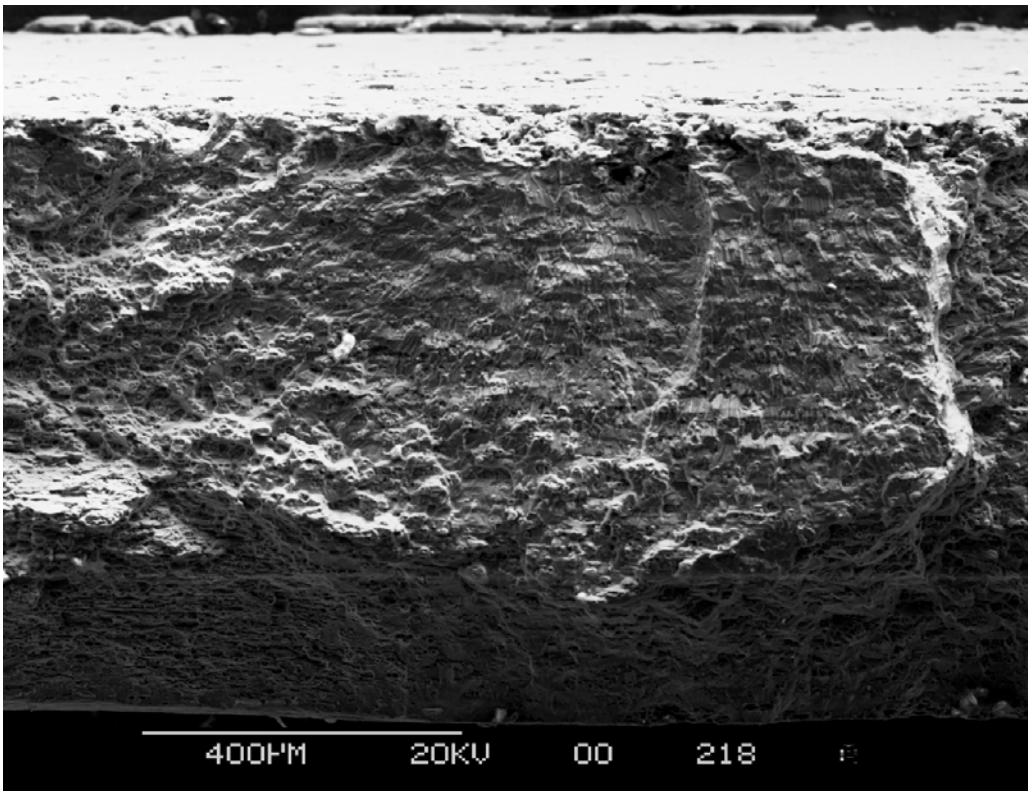
Figure B-62. Crack Origin #4 in Specimen 5914.

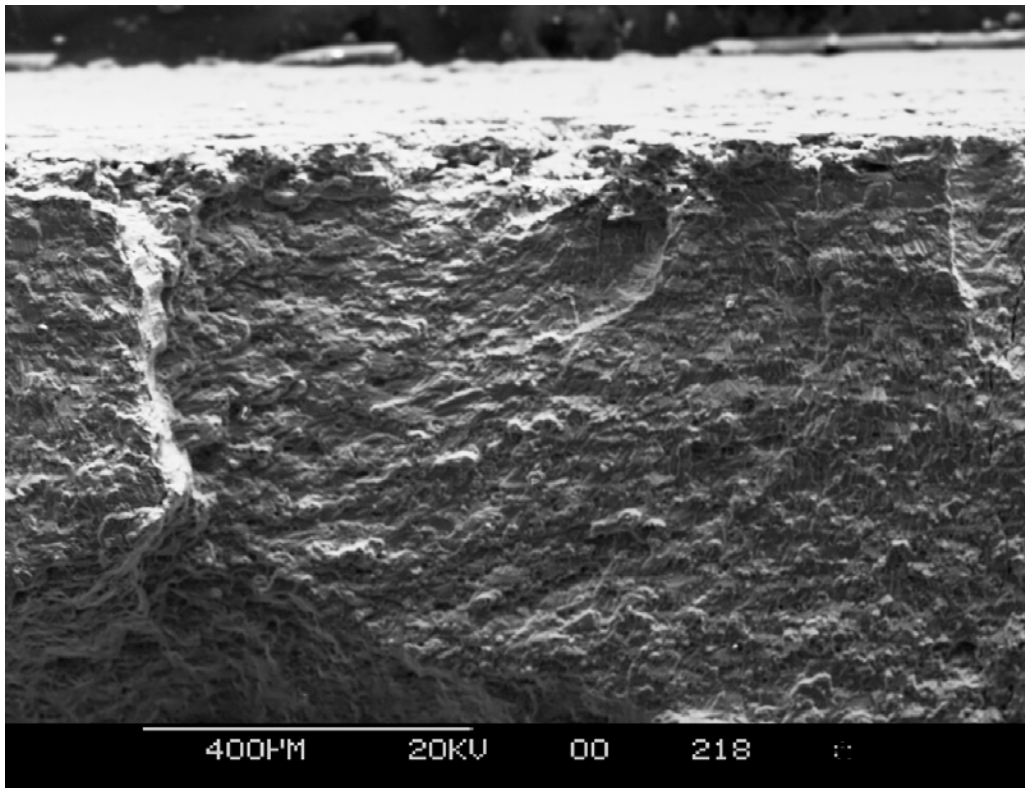
Figure B-63. Crack Origin #5 in Specimen 5914.

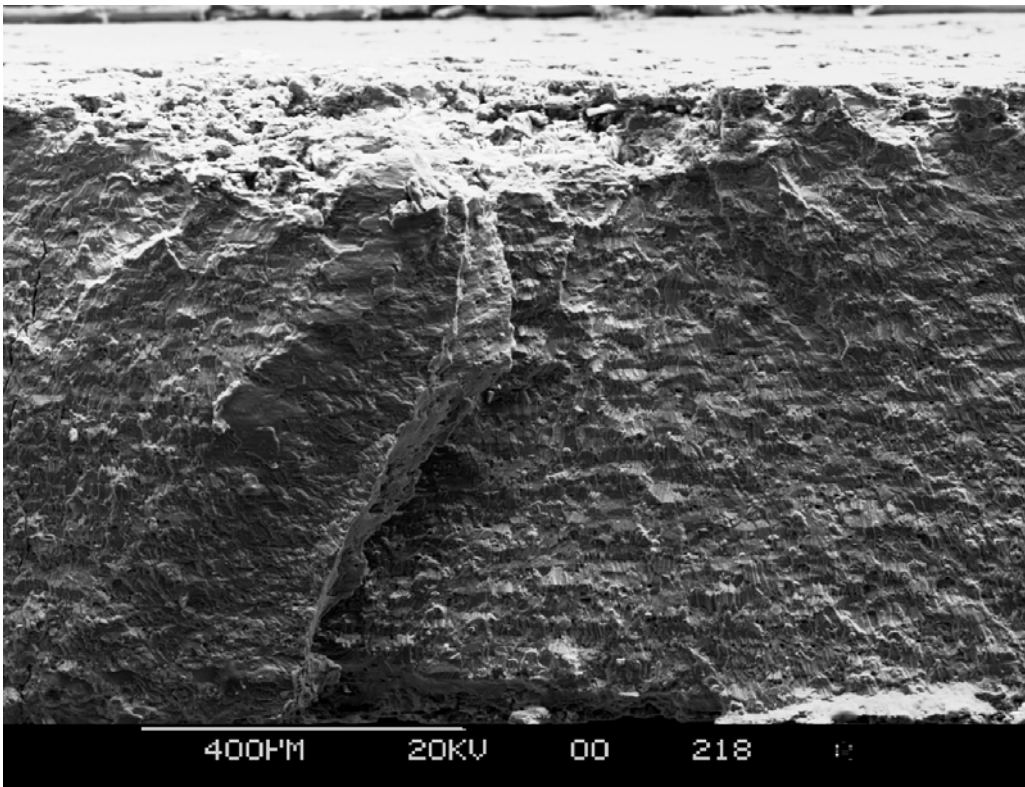
Figure B-64. Crack Origin #6 in Specimen 5914.

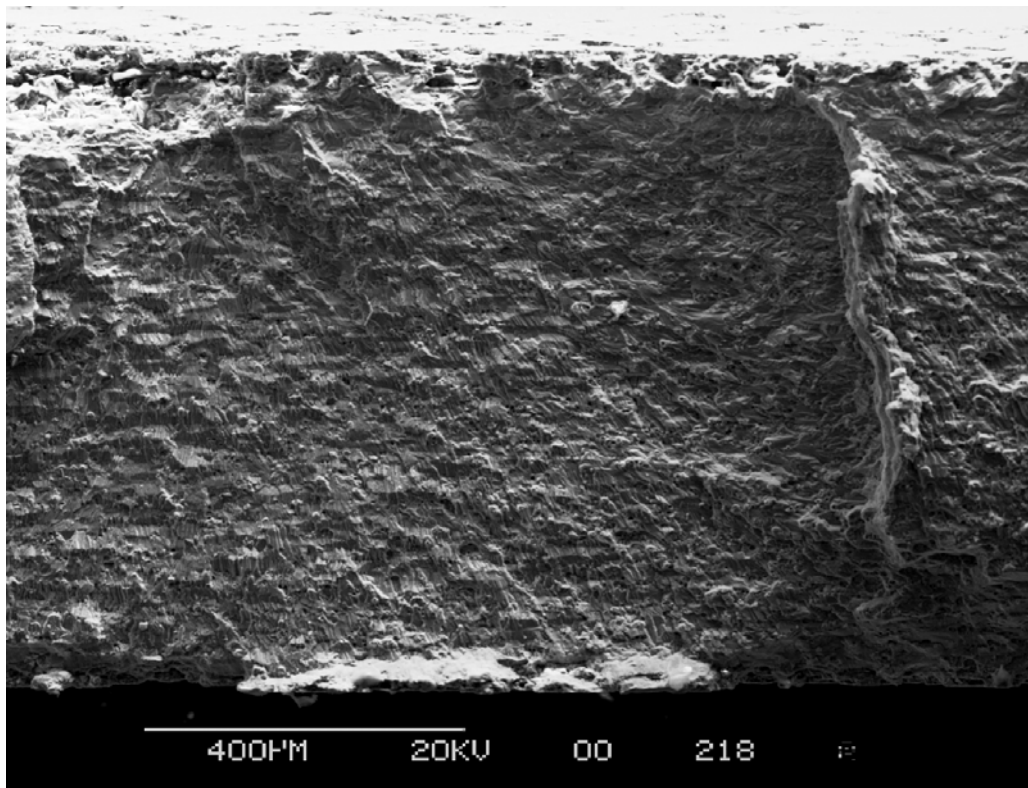
Figure B-65. Crack Origin #7 in Specimen 5914.

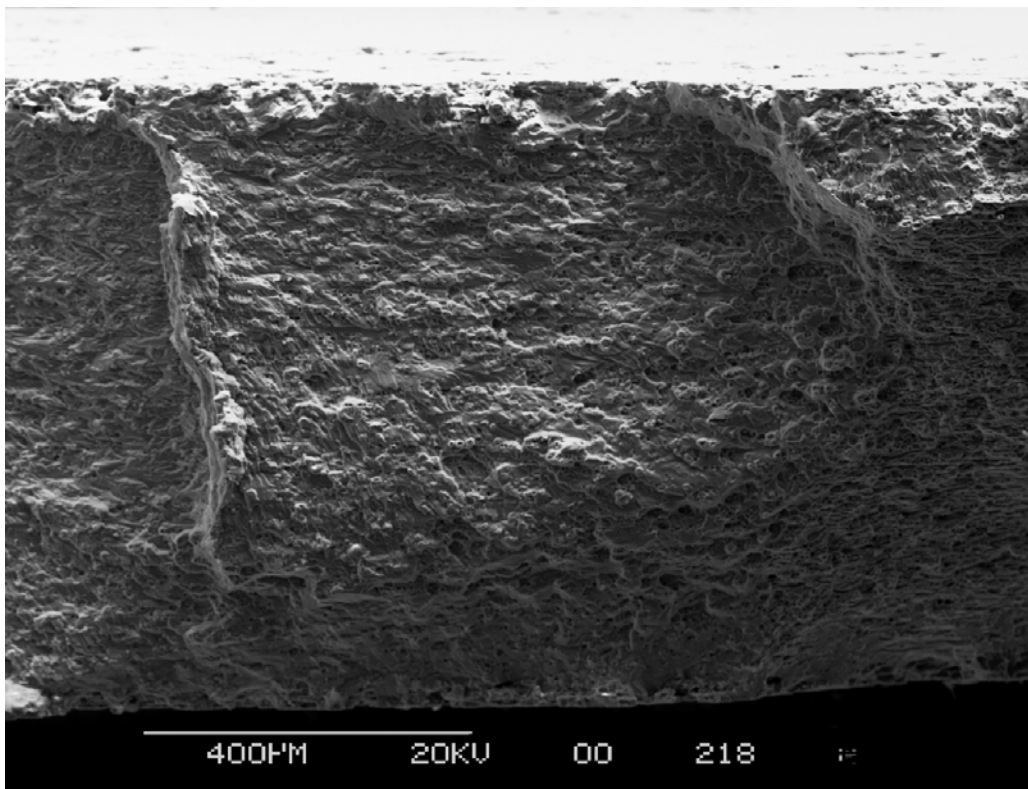
Figure B-66. Crack Origin #8 in Specimen 5914.

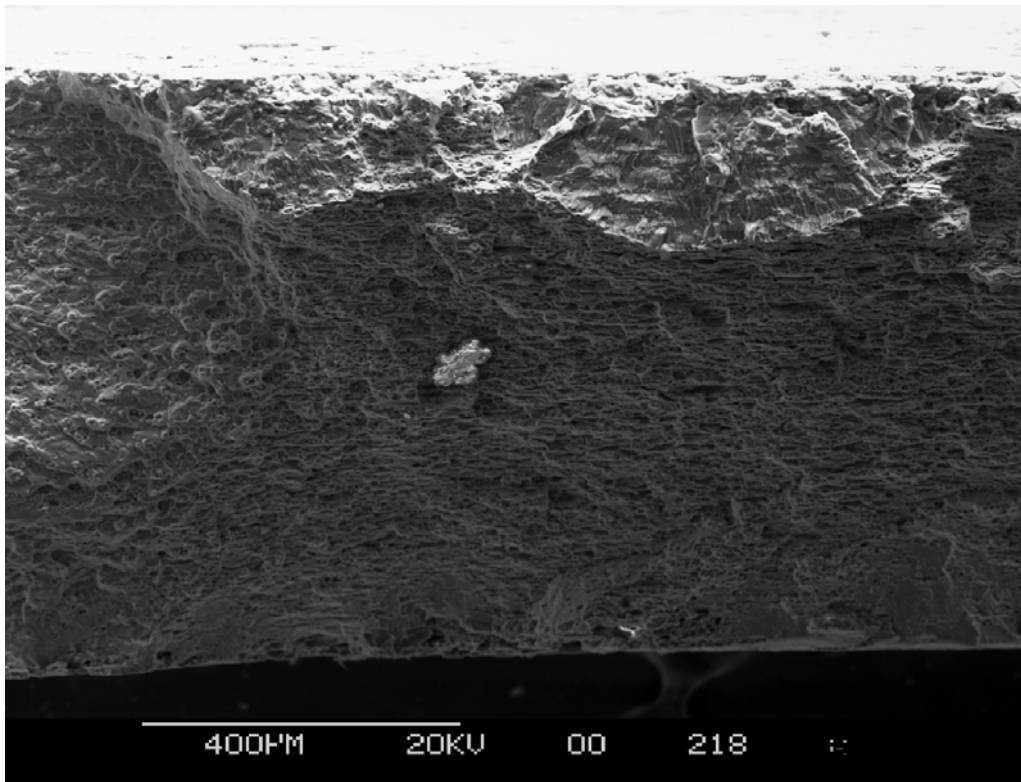
Figure B-67. Crack Origin #9 in Specimen 5914.

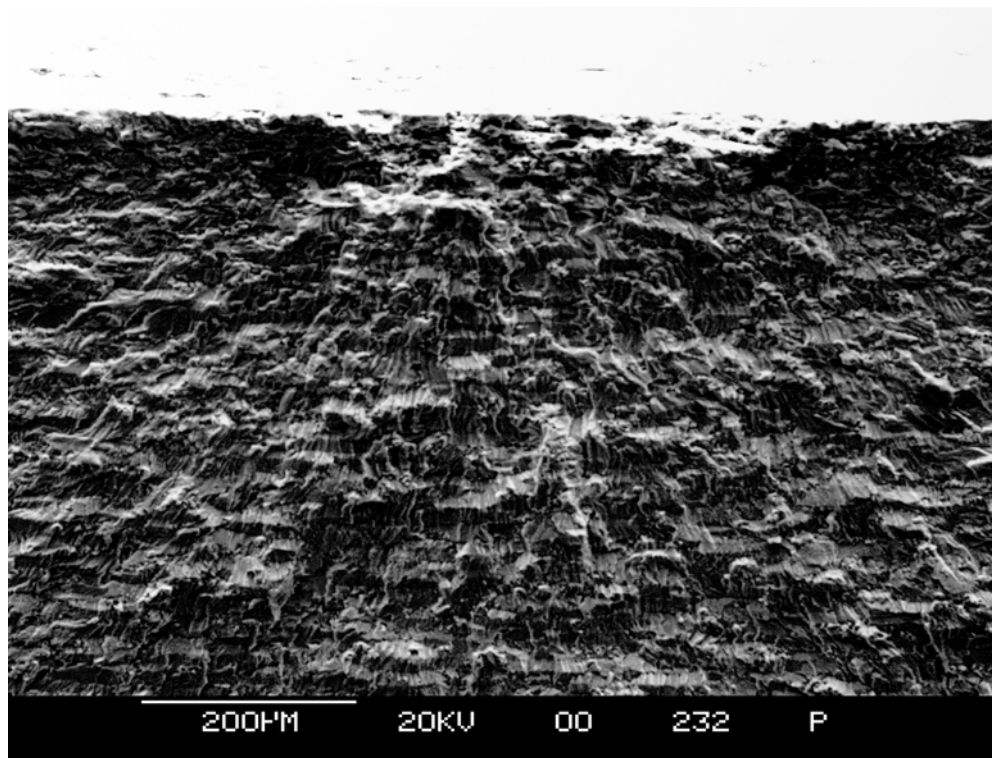
Figure B-70. Pit at origin of crack in Specimen 5925.

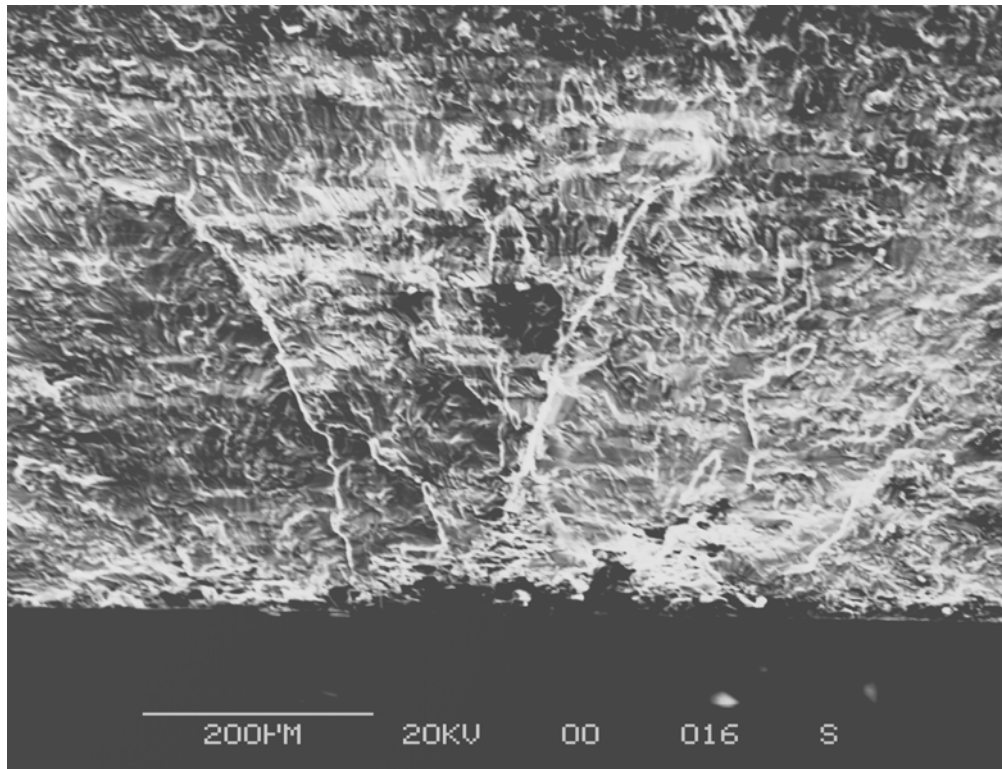
Figure B-73. Origin of Crack on Specimen 5926.

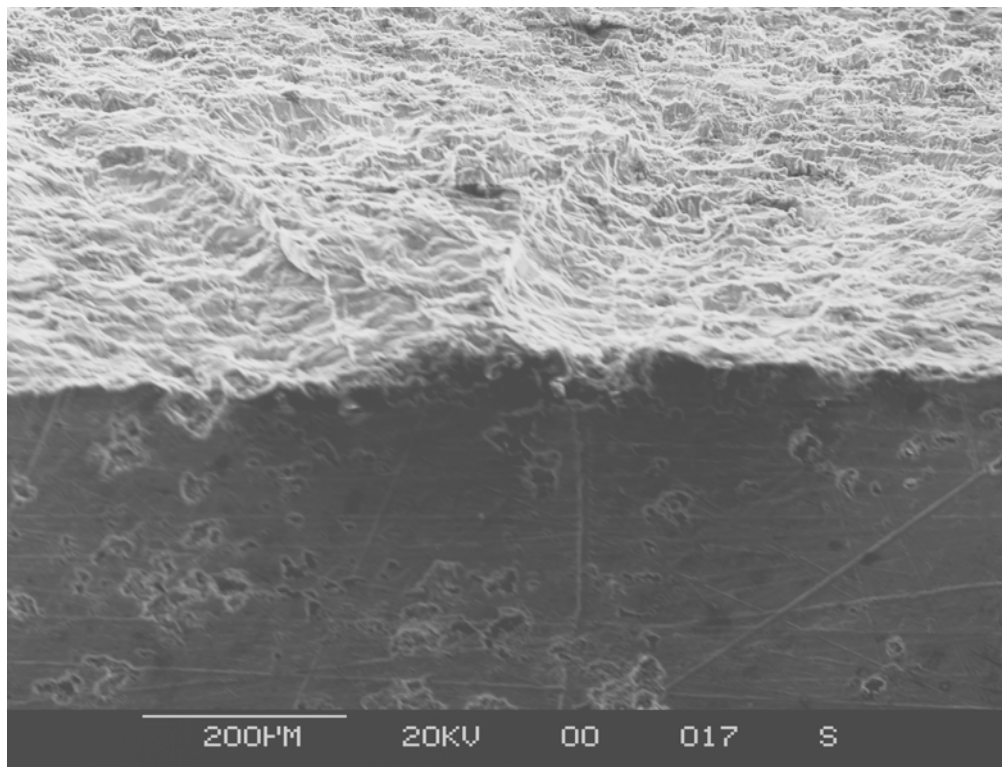
Figure B-74. Surface View of Crack Origin on Specimen 5926.

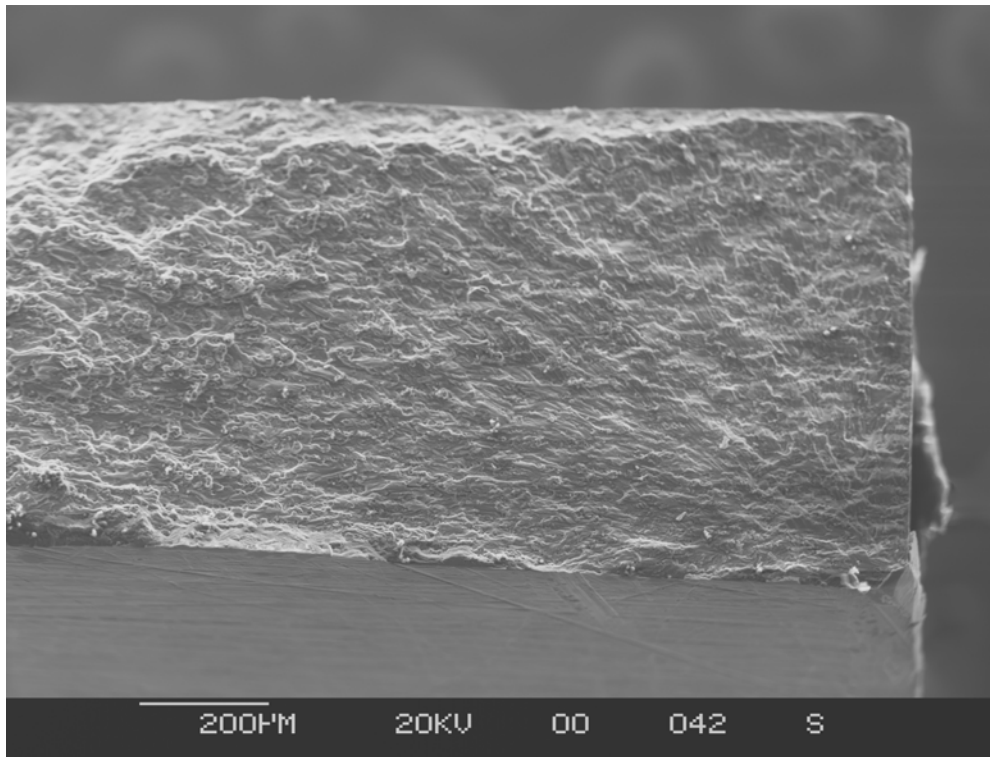
Figure B-75. Fatigue Crack on Fracture Surface of Specimen 5931.

Origin is at corner in lower right of the photograph.

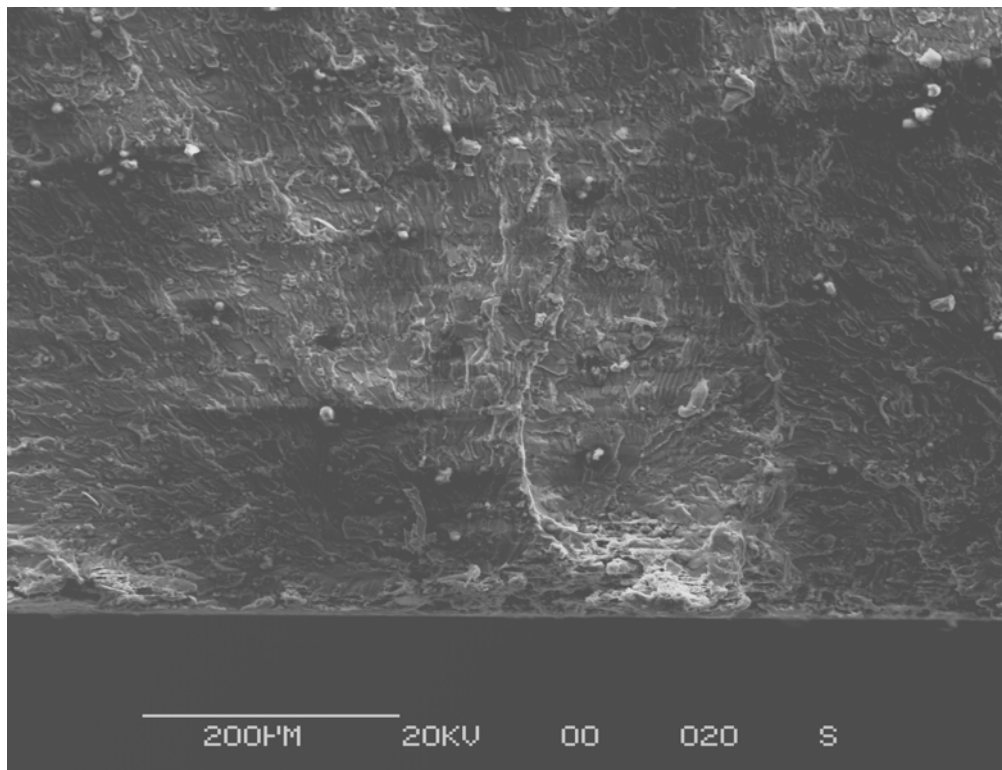
Figure B-78. Origin A (Fig. B-77) on Specimen 5933.

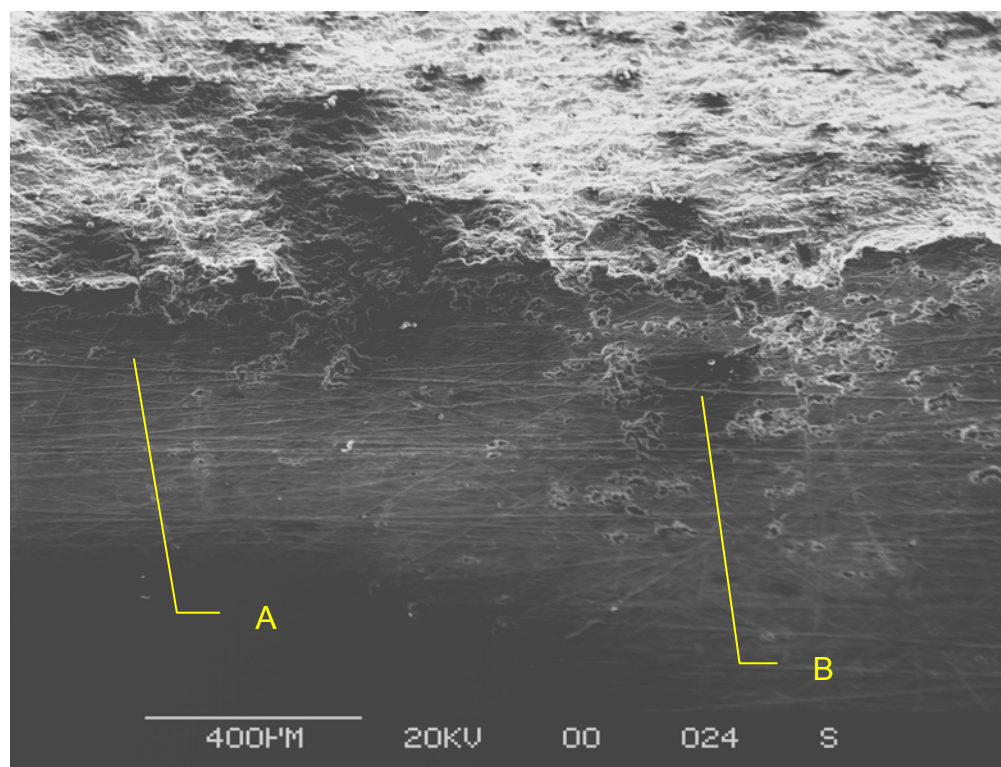
Figure B-80. Surface View of Crack Origins on Specimen 5933.

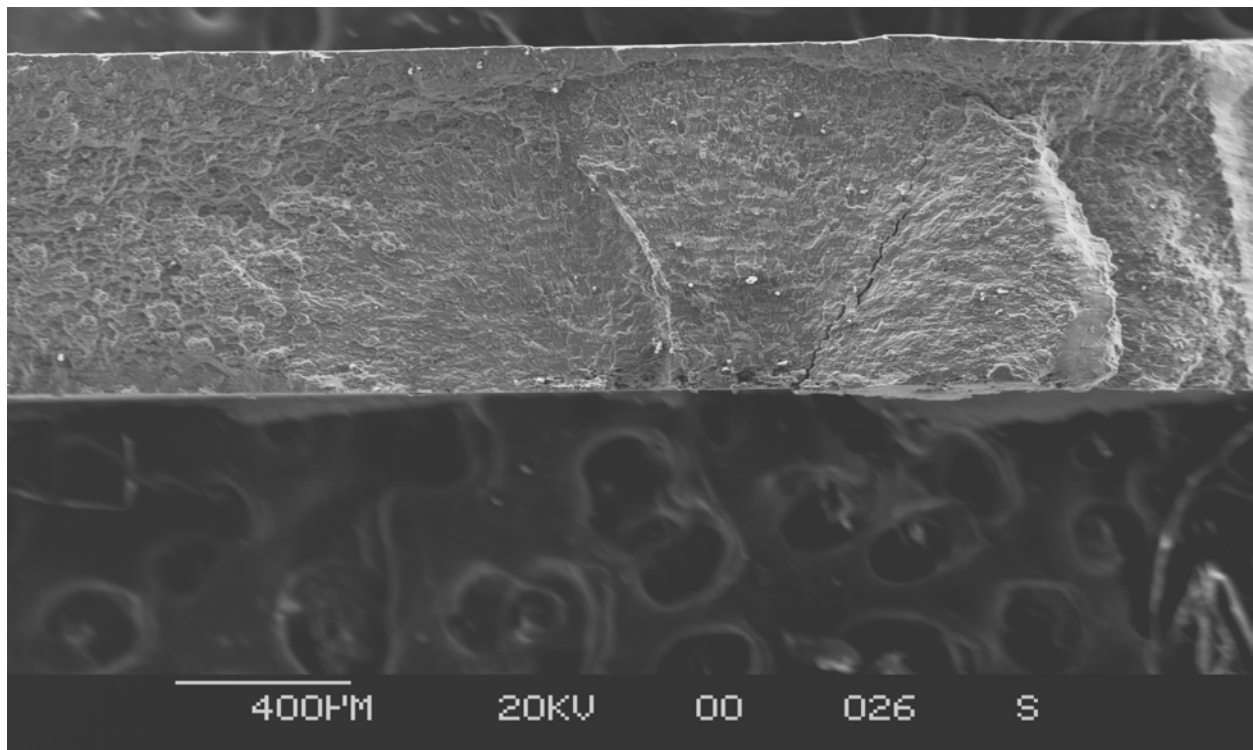
Figure B-81. Fatigue Crack on Fracture Surface of Specimen 5934.

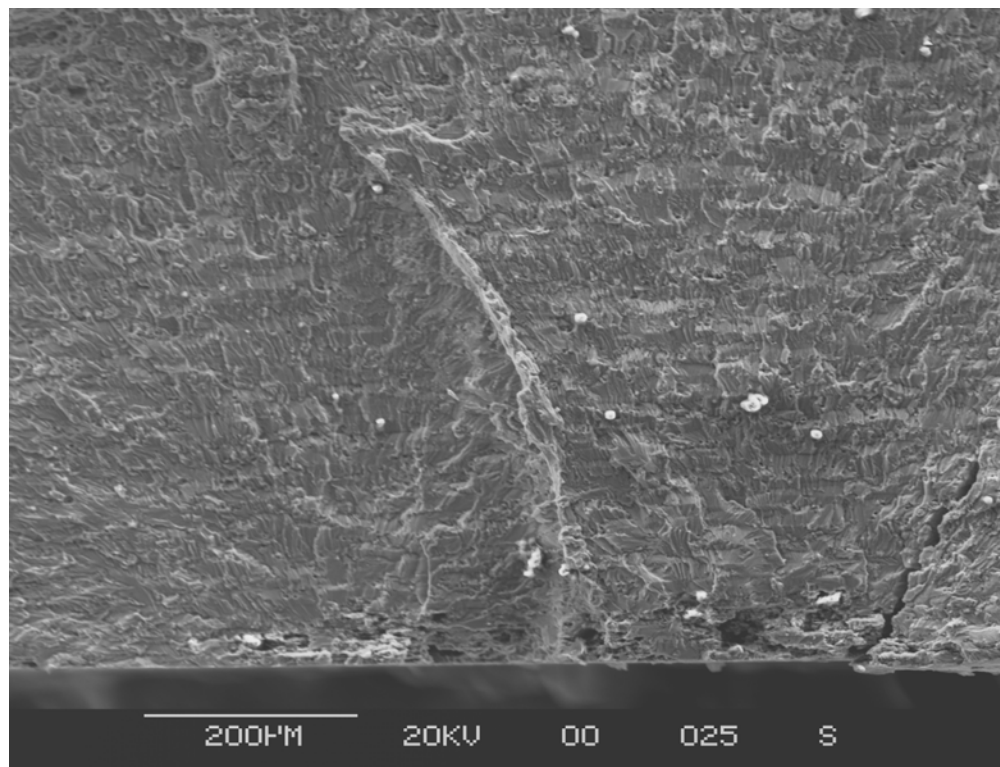
Figure B-82. Origin of Crack on Specimen 5934.

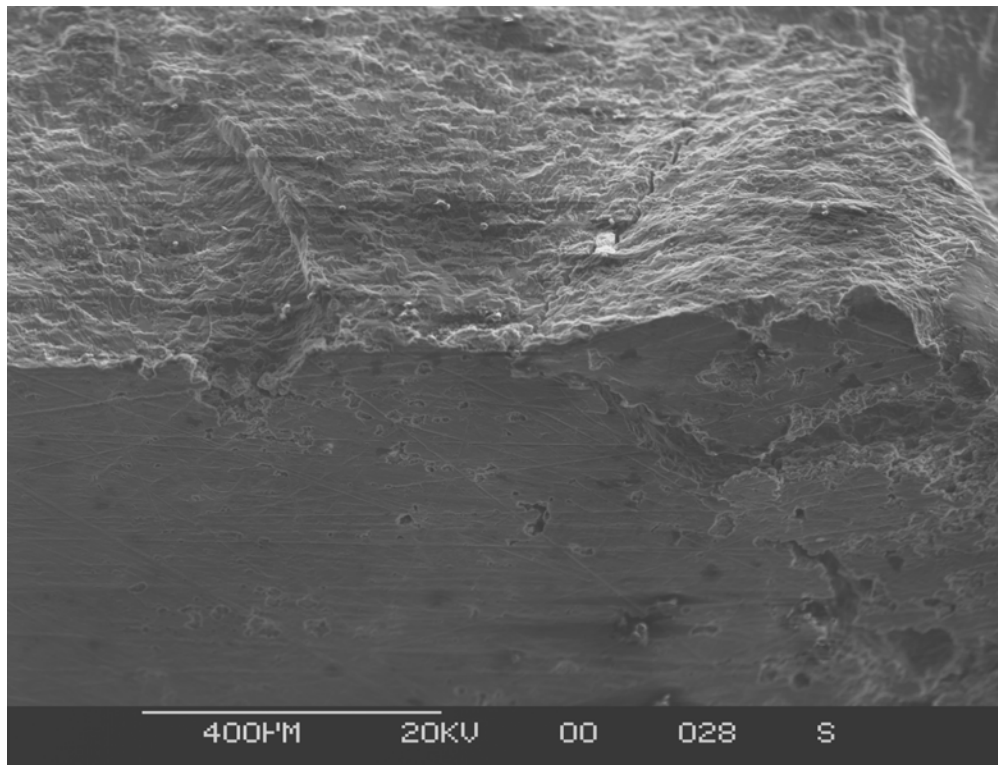
Figure B-83. Surface View of Crack Origins on Specimen 5934.

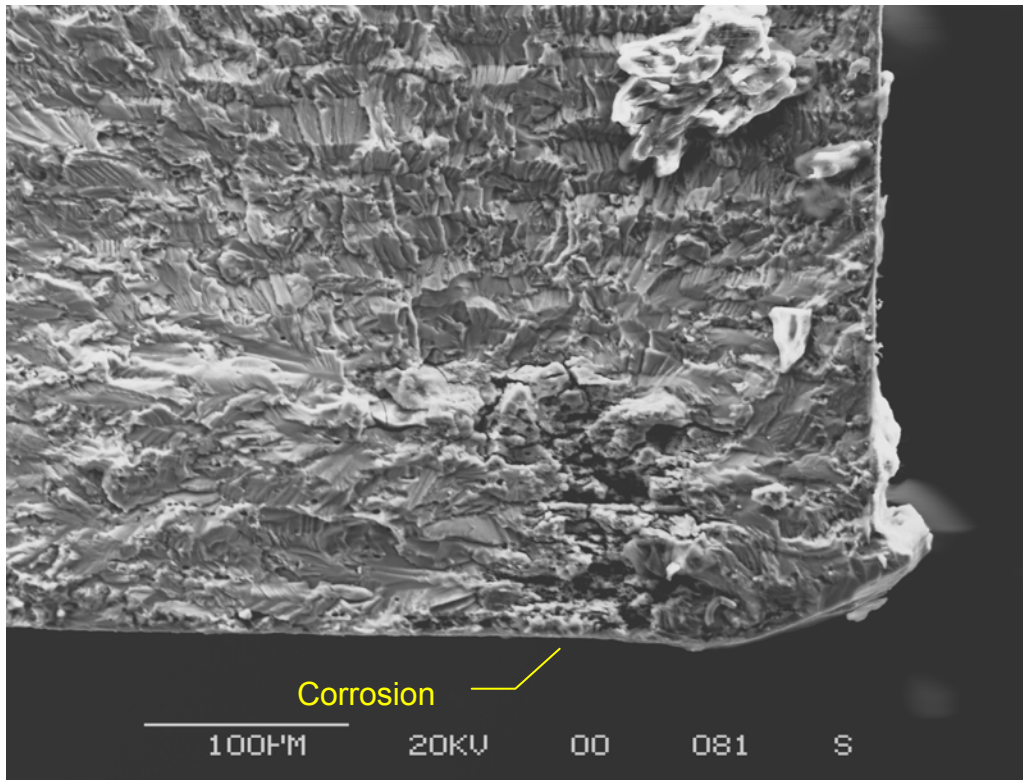
Figure B-85. Crack Origin on Specimen 5944.

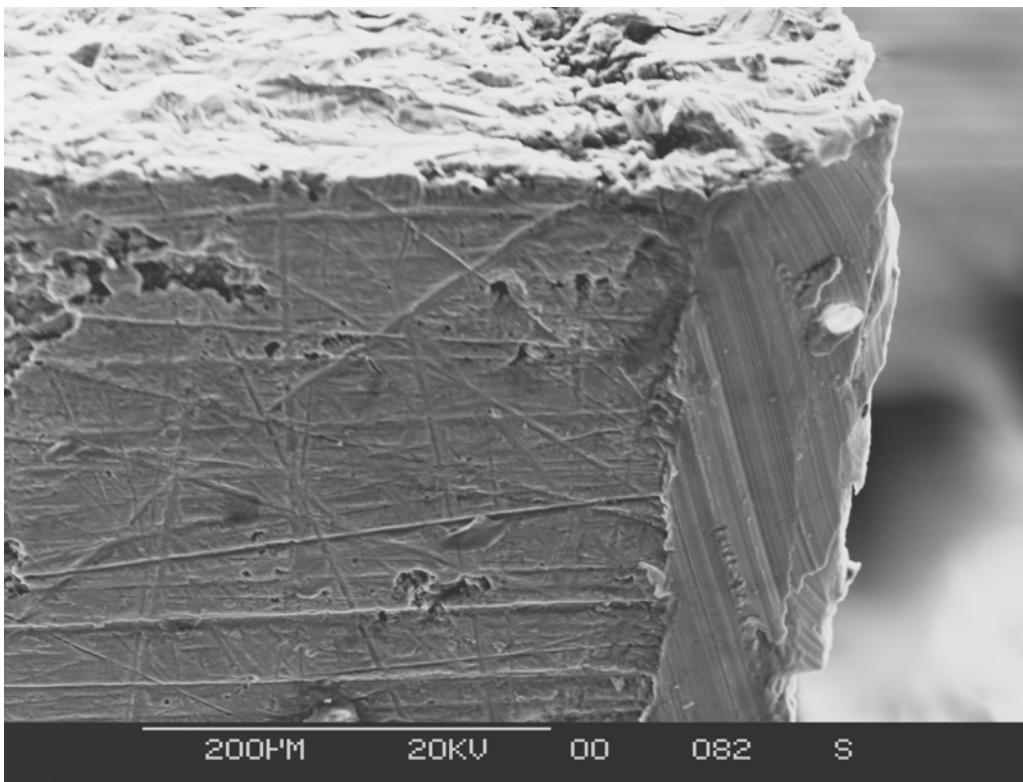
Figure B-86. Surface View of Origin on Specimen 5944.

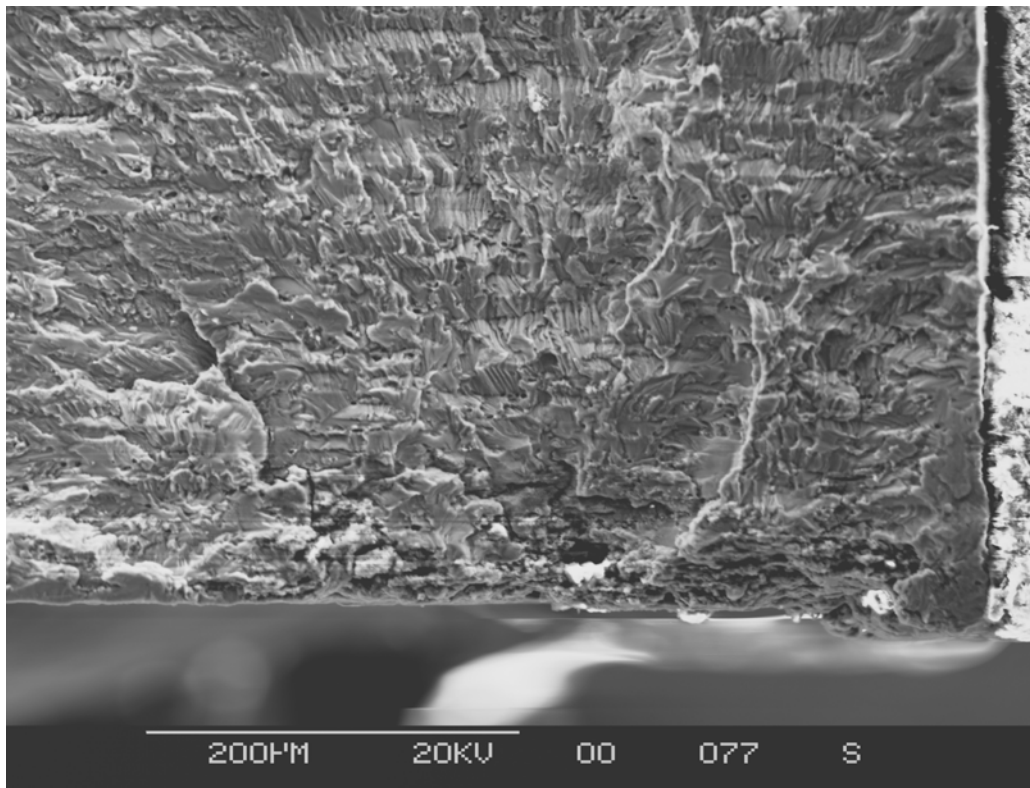
Figure B-88. Crack Origin on Specimen 5945.

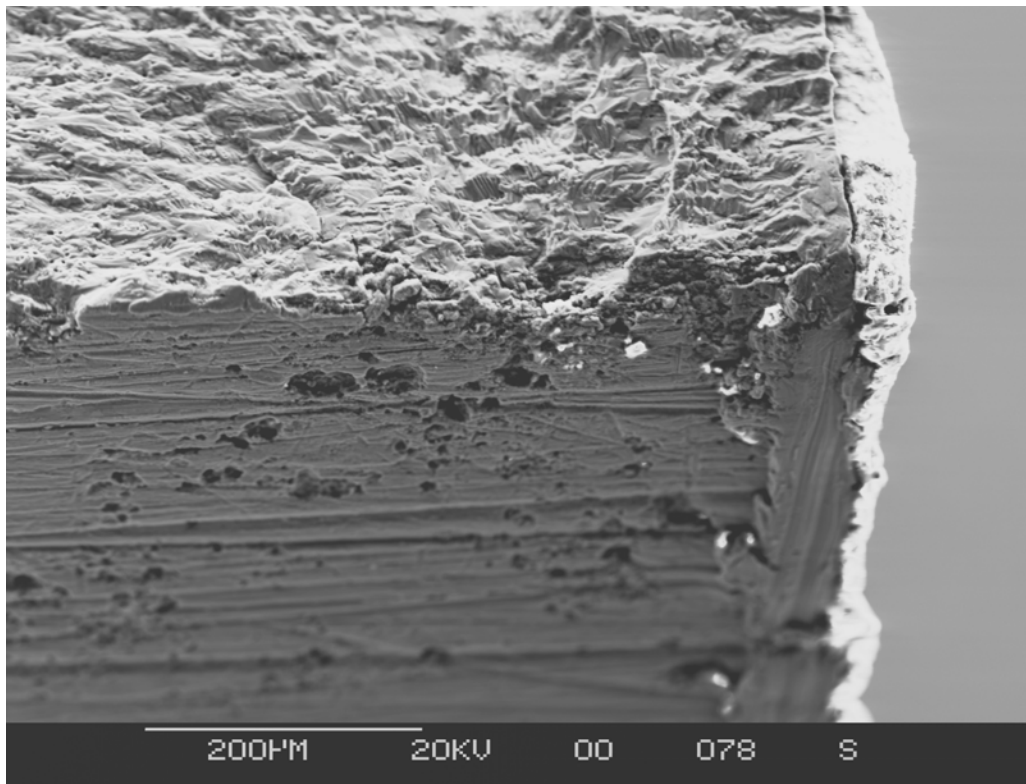
Figure B-89. Surface View of Origin on Specimen 5945.

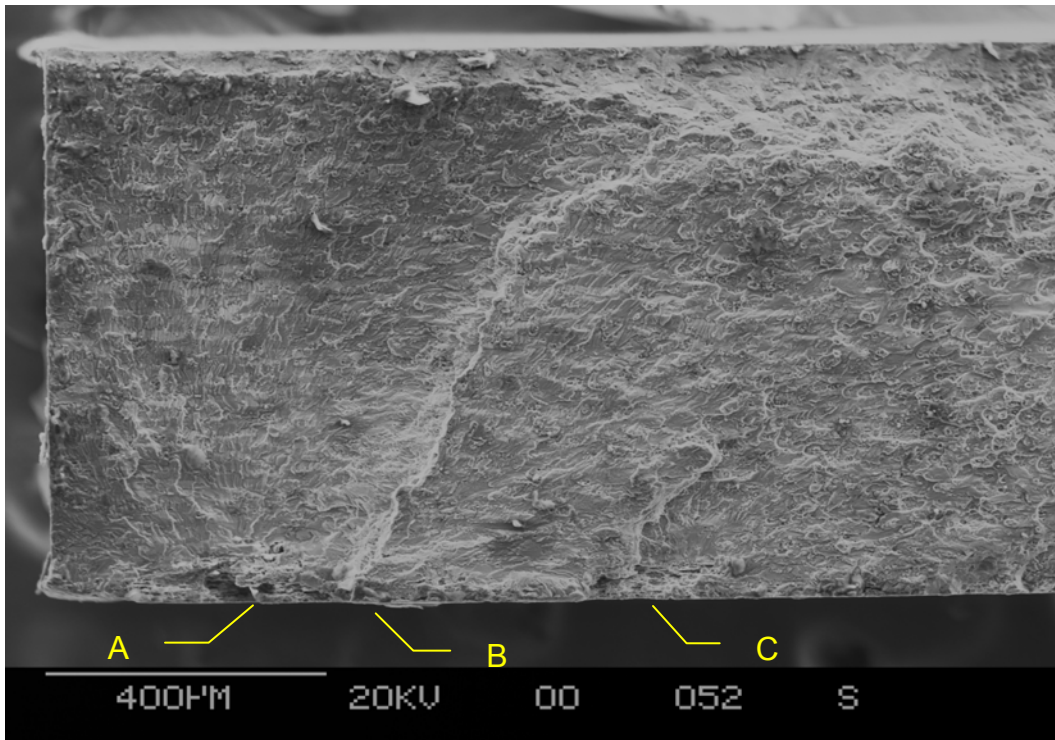
Figure B-91. Fatigue Crack on Fracture Surface of Specimen 5967.

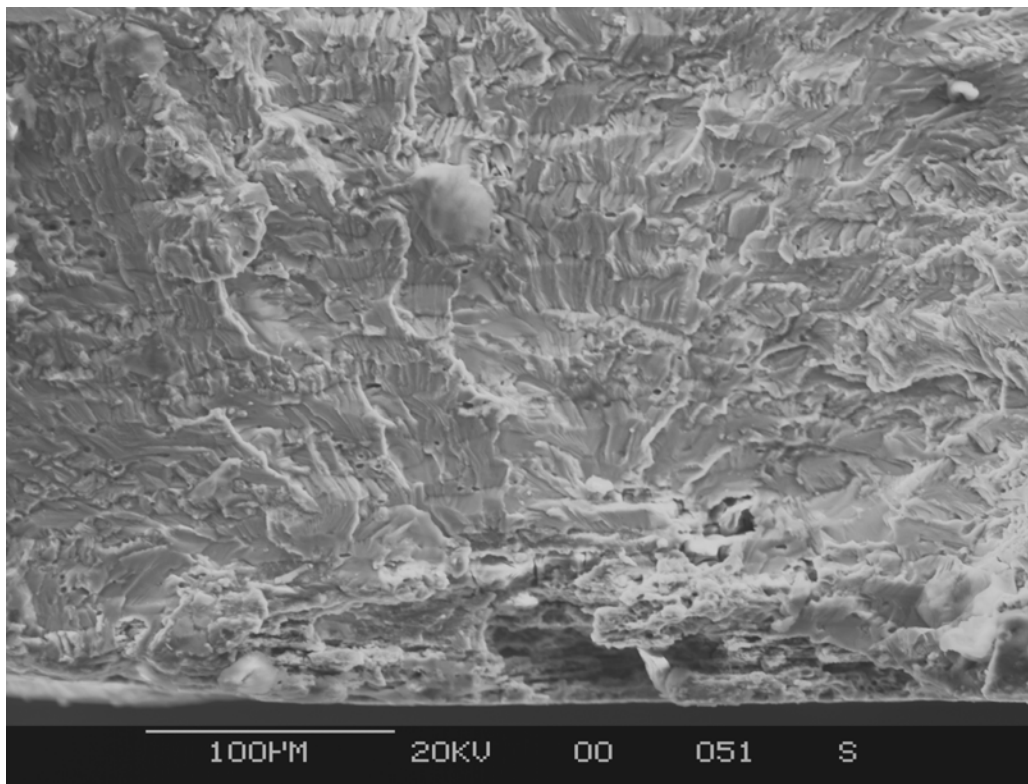
Figure B-92. Crack Origin A (Fig. B-91) on Specimen 5967.

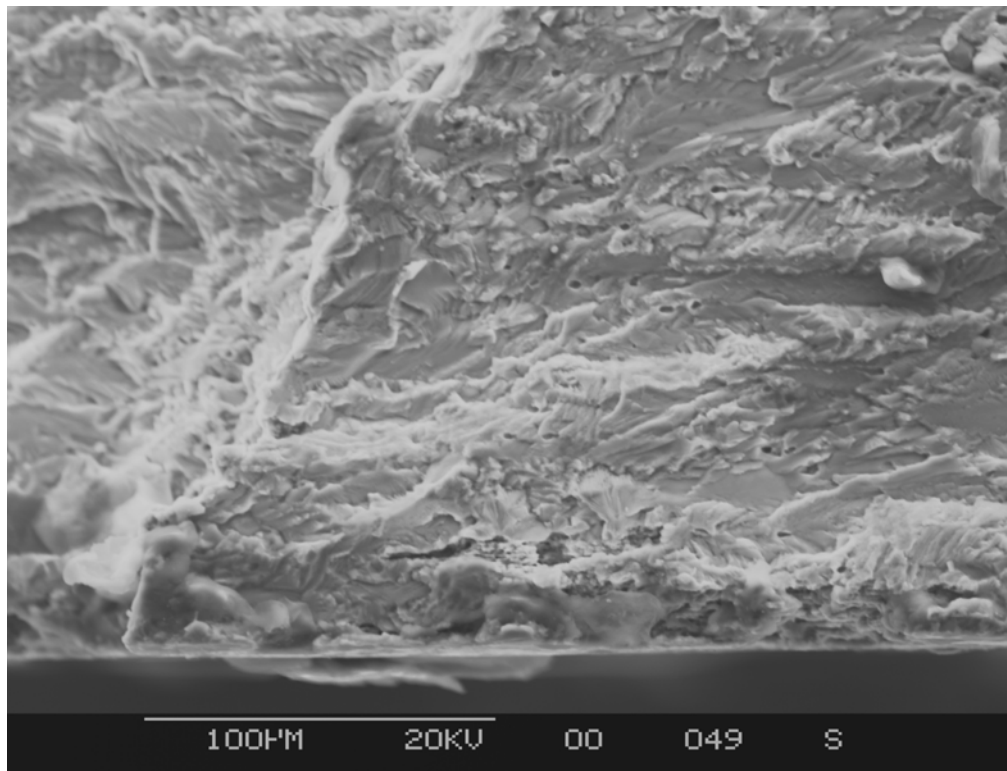
Figure B-93. Crack Origin B (Fig. B-91) on Specimen 5967.

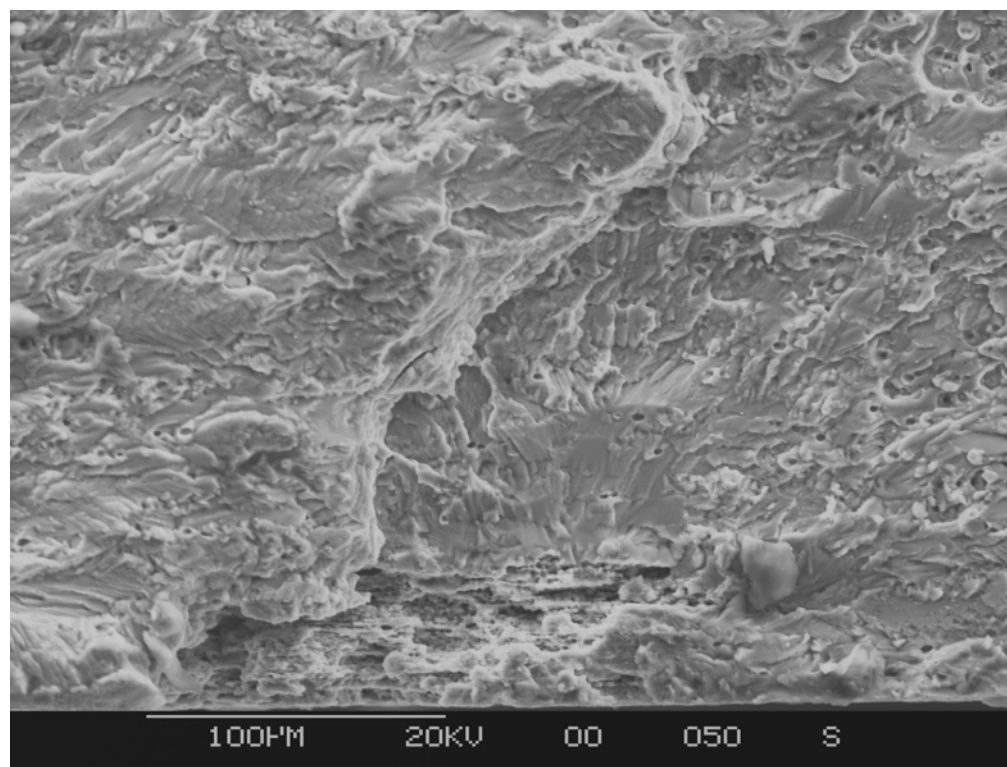
Figure B-94. Crack Origin C (Fig. B-91) on Specimen 5967.

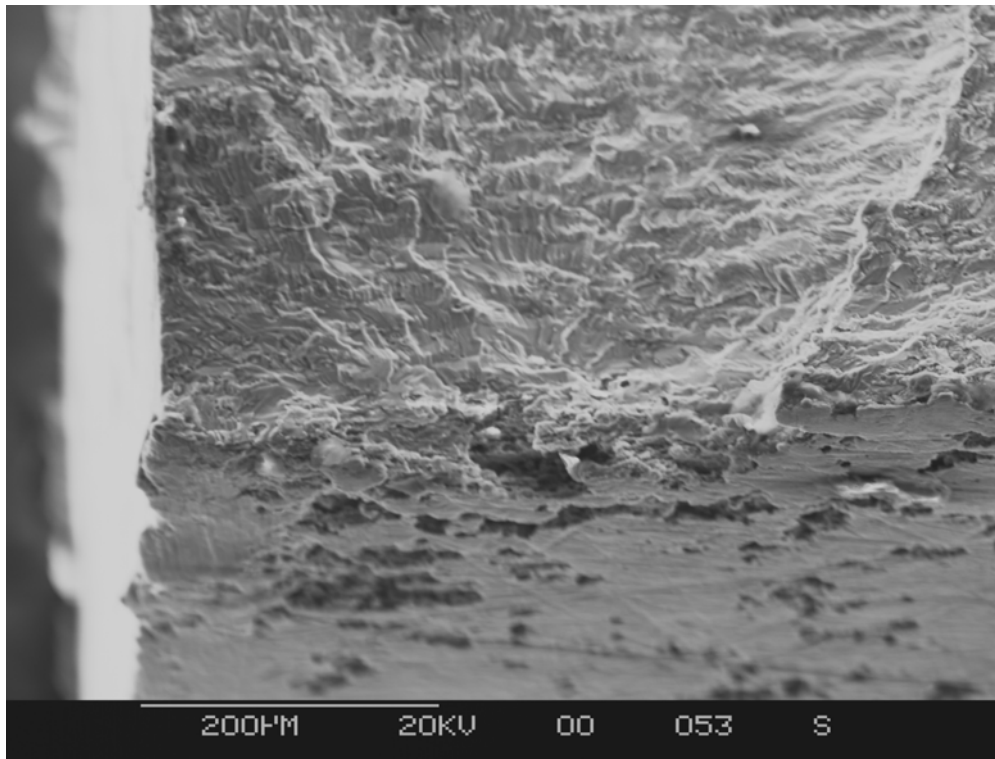
Figure B-95. Surface View of Crack Origin A on Specimen 5967.

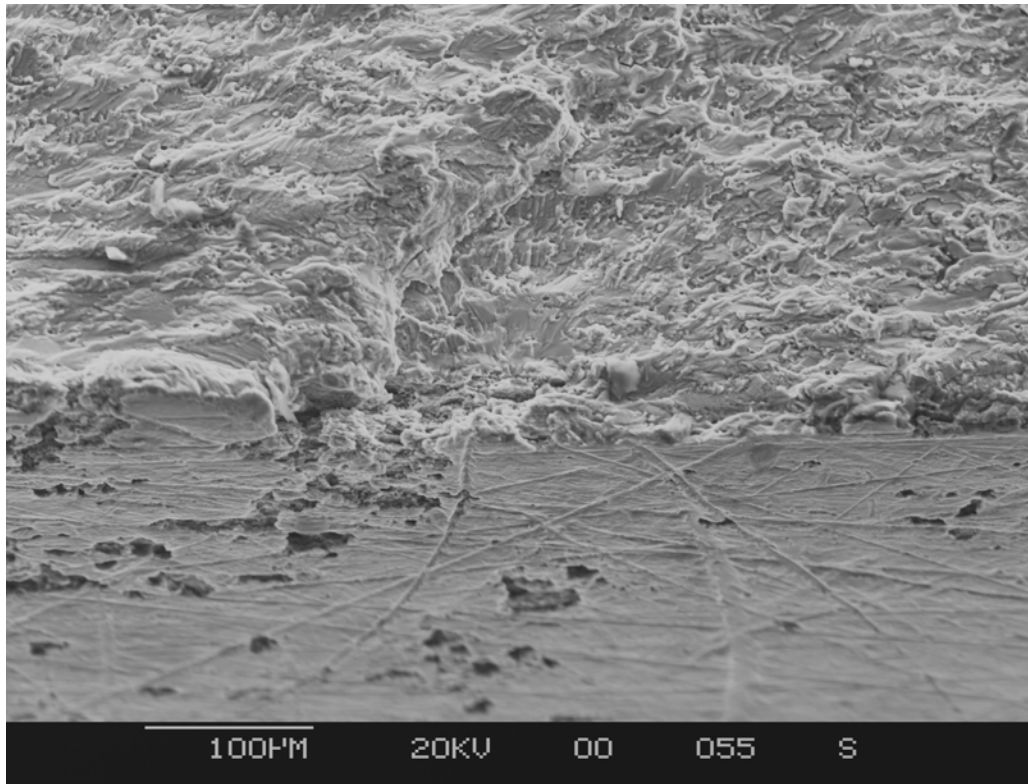
Figure B-97. Surface View of Crack Origin C on Specimen 5967.
